TECHNICAL MEMORANDUM

To: Bob Kirkpatrick
From: Allan Kirk
Date: February 15, 2002
Re: Reopening of the Portals of the Lower Spaulding Adit and the McLaren Adit or Winter Tunnel

The McLaren Adit (or the Winter Tunnel)

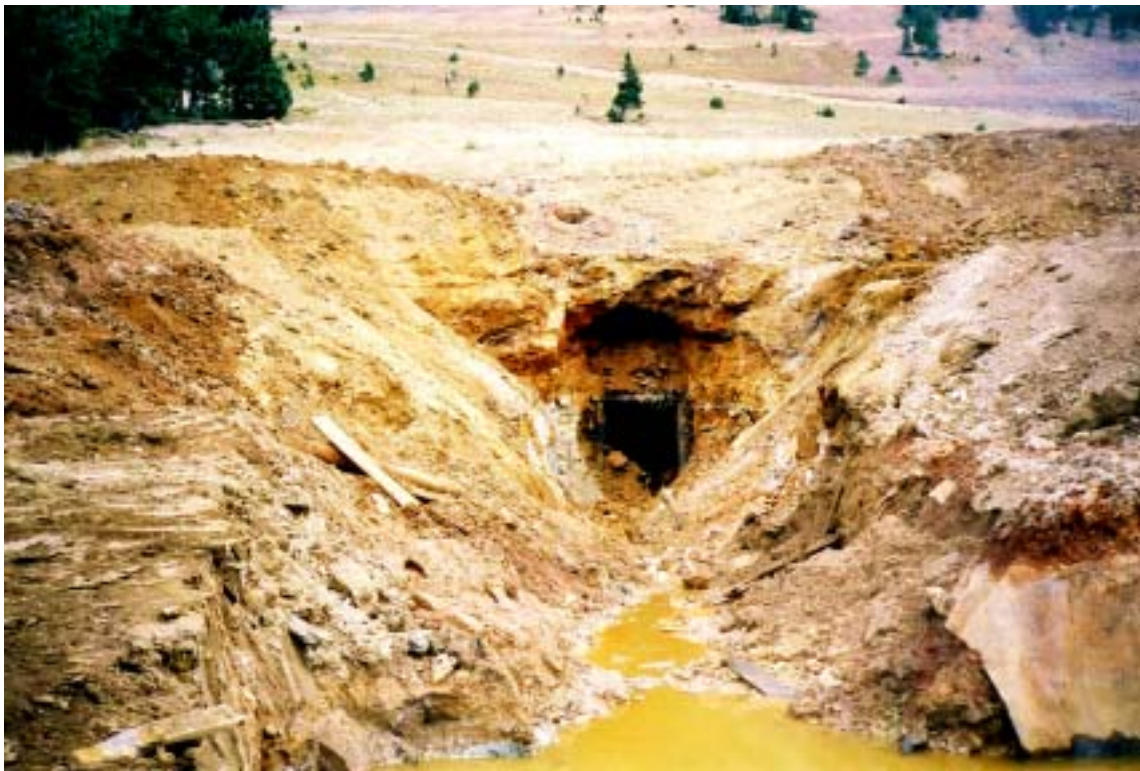
Once the sediment ponds were constructed, the collapsed portal was opened from above, and water pumped into the drainage channel. Once the water level dropped a few feet, the collapsed portal was breached with excavator, and the cave-in slowly lowered in elevation to drain the remainder of water from the mine. Figure 2, shows the breached portal dam draining the adit, and the condition of the portal area during the draining process. Figure 5 shows the lower drainage pond and discharge pipe during active dewatering.

Figure 2. Draining of the Winter Tunnel once the portal dam had been breached.

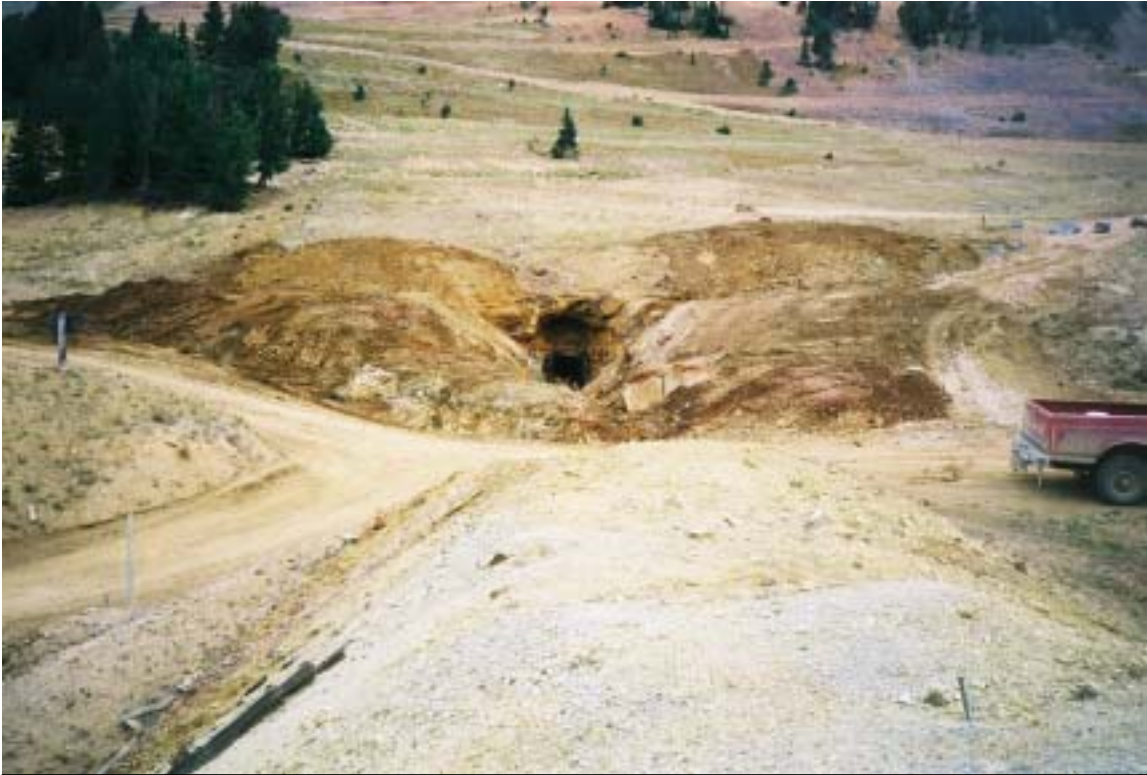
The area around the portal was cleaned up, and regraded once the mine was reopened and drained (Figure 6). A construction safety fence and a plywood portal closure were constructed for the winter.

Figure 6. Clean-up and regraded portal site of Winter Tunnel after draining.

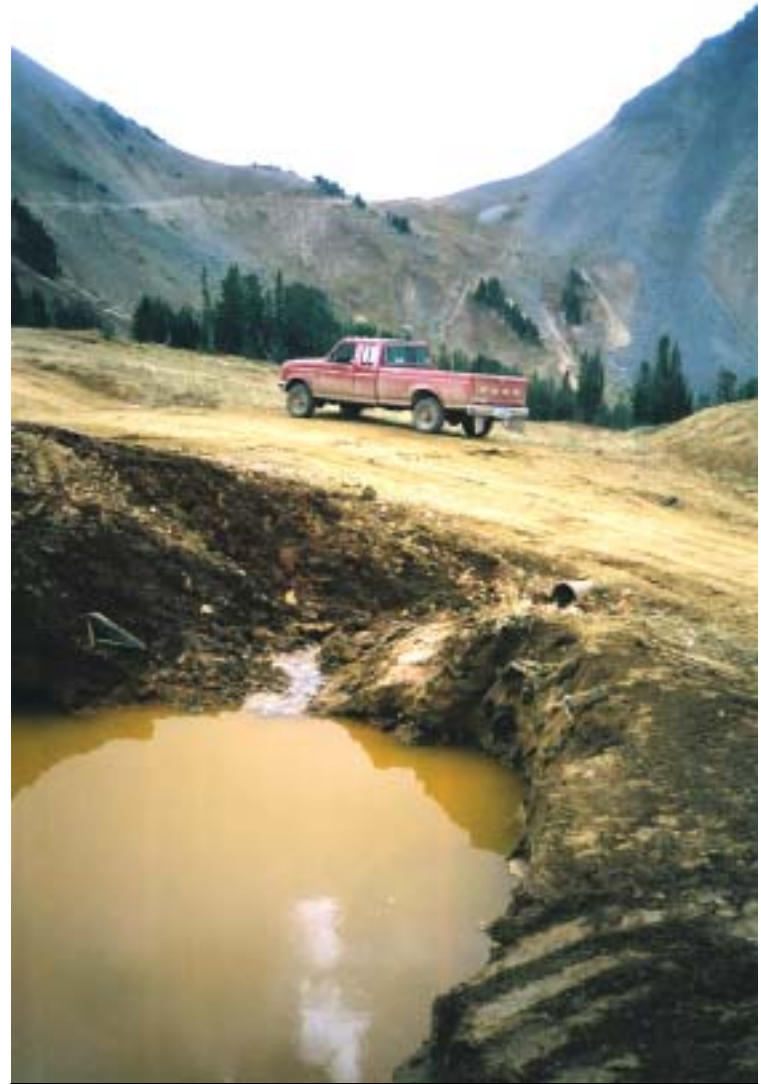
The up-hill drainage basin or settling pond (Figure 4) was constructed immediately outside of the mine portal, uphill of the main access road and the culvert that drains the working under the road. This pond was dug about 15 feet deep and was excavated into bedrock to allow for maximum settling of sediments discharged from the mine. This basin was not lined.

Figure 4. Upper settling pond at the Winter tunnel showing culvert under the road and upper portion of the waste rock dump.

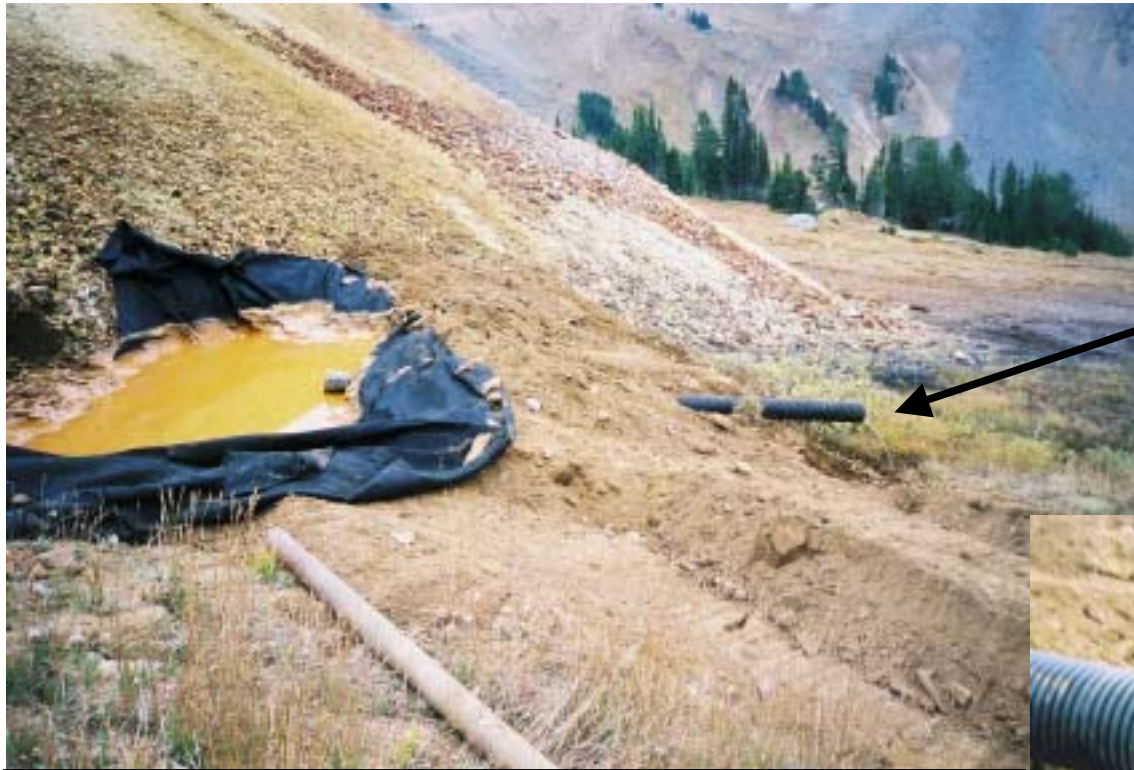
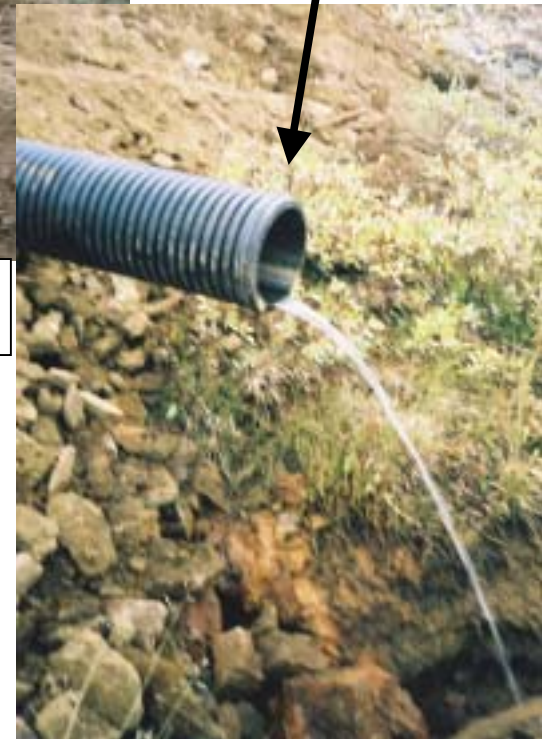
Lower Pond Outflow

Figure 5. Lower settling pond and discharge pipe during active draining at the Winter Tunnel.
